Courtesy Safety Notice: COBRA buckles

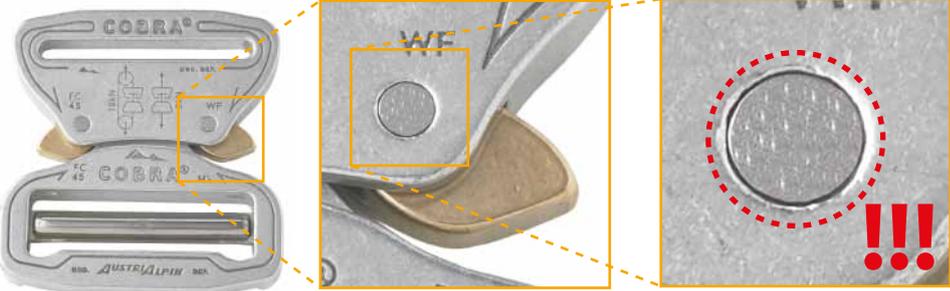
it has come to our attention that in an extremely small quantity (0.00005% = 1 out of 2 million) of COBRA buckles there may exist parts where the rivets have **not** been **press fixed**.

This results in the rivets being loose and the release clips detach. COBRA buckles in all different versions and sizes can be affected. As we are dedicated to the 100% function, performance, quality and safety of our products, we ask all our clients and end users of COBRA buckles to **do a visual check**:

NOT Correct
The rivet does not show any circular embossing

If you notice a buckle that is NOT riveted or you do have any concerns, STOP USING the product immediately and get in contact with us: info@singingrock.com or via phone +420 481 585 007

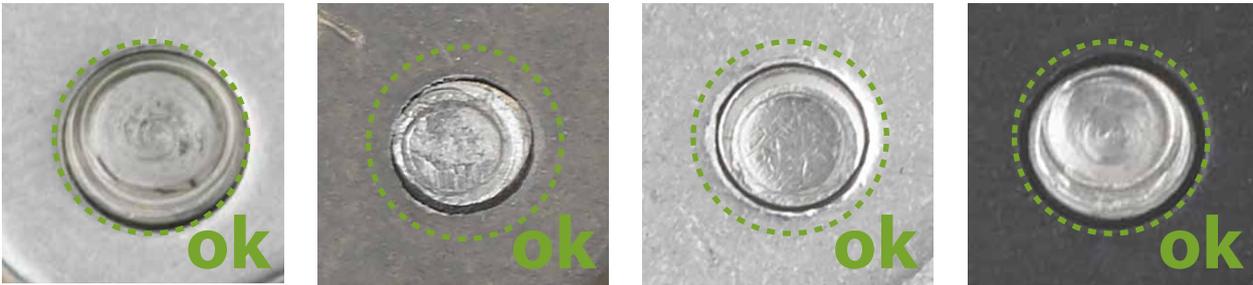
Correct
The rivet shows an embossing in the form of a ring on both the front and back sides of the rivet.
Do not manipulate the rivets by mechanical action.
