Inspection Notice

Subject: BuckGrab Rope Length Adjusting Device (LAD)
'LAD' Units Covered By This Notice Are On Product
With a 'T' Manufacturer's Code and Manufacture Date 10/17 or Prior

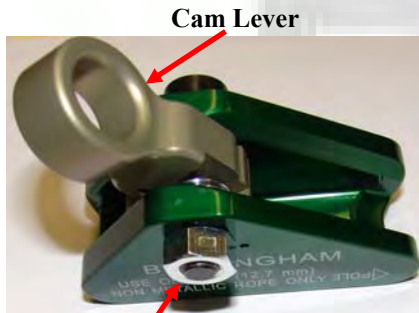
We recently received two returns in which the center lock nut of the BuckGrab Length Adjusting Device "LAD" (with a 'T' manufacturer code) was reported to have come loose on our P/N 9-8 Adjustable Positioning Lanyard "APL". The center lock nut at issue attaches to the bolt securing the cam to the body of the BuckGrab "LAD" (ref. Fig. 1a & 1b). The "LAD" units of the returned "APL's" were from a single shipment and from a single subcontractor. Center lock nuts include a distorted thread design and are identified by two or three equally spaced round or rectangular impressions compressed into the flat sides of the nut (ref. Fig. 1a). Inspection revealed that the BuckGrabs involved may have been manufactured without the center lock nut being torqued down to our specification. While there have been no reported injuries due to this occurrence, Buckingham believes it is important to advise other customers of this issue so that affected units can be immediately inspected and adjusted, if needed. Affected units from this shipment are those with a 'T' manufacturer code (ref. Fig. 2) and were manufactured through October 2017.

Center Lock Nut

- Inspect and torque the center lock nut of your BuckGrab “LAD” using the Inspection and Torque Procedures outlined below. **If you are unsure or uncomfortable with making the inspection or the torque update (if needed), remove the equipment from service and notify your Supervisor, Safety Director or contact Buckingham immediately at 1-800-937-2825 for clarification. Use of a BuckGrab “LAD” with a loose or missing center lock nut may result in serious injury or death to the user.**

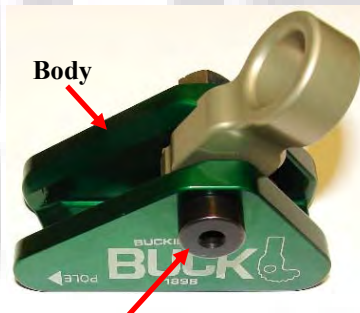
Fig. 1b

Shoulder Bolt

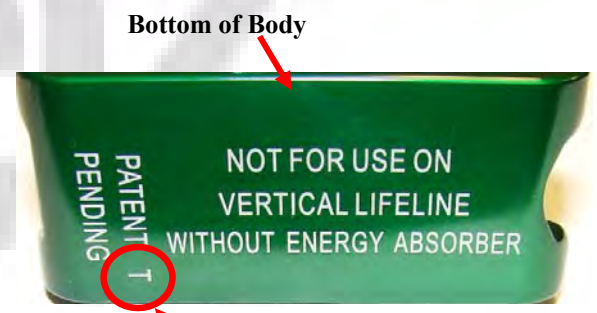
Fig. 2

Manufacturer's Code

Note: For clarity purposes, the rope was removed from the BuckGrab.

1. Does your BuckGrab "LAD" have a 'T' manufacturer's code? Manufacturer's code is located on the bottom of the BuckGrab Body (Fig.2). **If "No", your unit is not subject to this Notice.**
If "Yes", proceed to step 2 below.
2. Does your Adjustable Positioning Lanyard "APL", SuperSqueeze "WPFRD" models with Rope or EZSqueeze "WPFRD" models with Rope, (Fig. 3 – 5) have a manufacture date on or before October 2017? The date of manufacture is expressed in a 4 digit month/year, e.g."10/17". See Fig. 6 – 7b for product label manufacture date location. **If "No", your unit is not subject to this Notice.**
If "Yes", proceed to step 3 below.

Note: All subject item units with a 'T' manufacturer code (ref. Fig. 2) and product manufacture date 10/17 or prior are subject to this Notice.

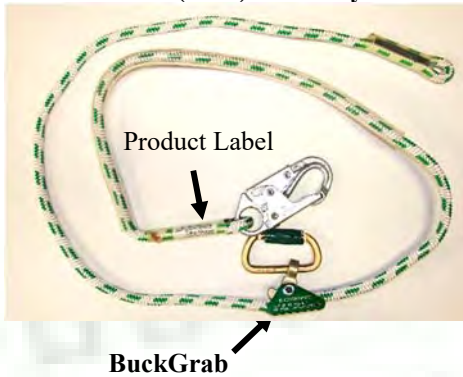
Note: All Adjustable Positioning Lanyards “APL”, SuperSqueeze “WPFRD” models with Rope or EZSqueeze “WPFRD” models with Rope that have a ‘T’ manufacturer’s code and a manufacture date of 10/17 or prior are subject to this Notice.

Fig. 3
9-8 Adjustable Positioning Lanyard (APL) Assembly

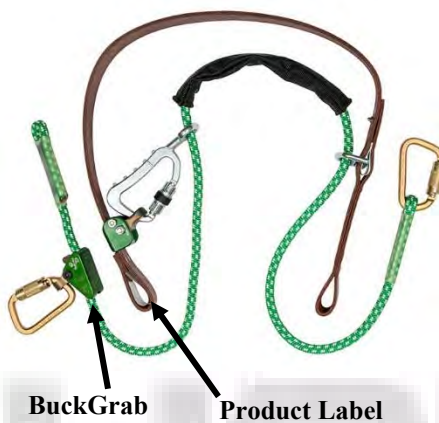
Fig. 4
SuperSqueeze w/ Rope (WPFRD) Assembly

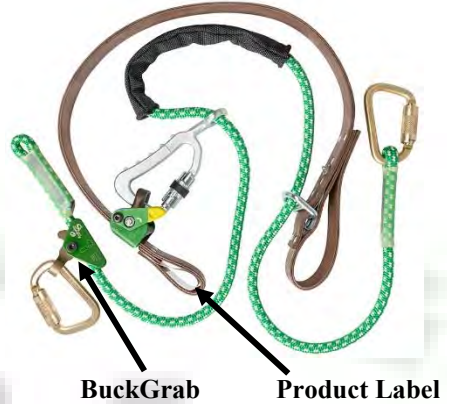
Fig. 5
EZSqueeze w/ Rope (WPFRD) Assembly

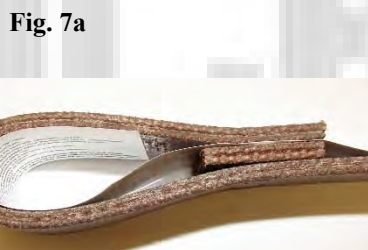
APLs product label located under shrink tube on the stitched end of the lanyard with the hardware

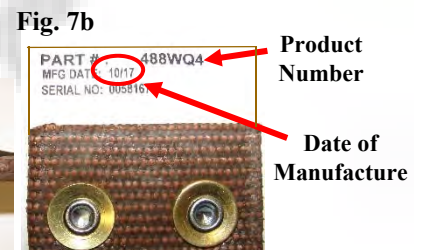
SuperSqueeze / EZSqueeze product label located at fold over on end of outer strap

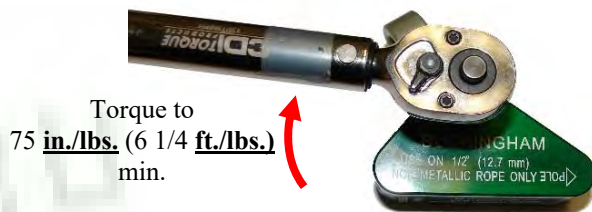
Fig. 8

1. Using the 3/16" Allen wrench and 1/2" Wrench or Torque wrench, tighten the center lock nut until it comes in contact with the shoulder of the bolt.
2. Next, if using a torque wrench, torque the center lock nut to **75 in./lbs.** (6 1/4 **ft./lbs.**) min. (Fig. 8). If using the 1/2" wrench, fully tighten the center lock nut by applying an additional 1/8 turn of the nut on the bolt which will generate the approx. **75 in./lbs.** (6 1/4 **ft./lbs.**) of torque required (Fig. 9).
