Courtesy Safety Notice: COBRA buckles

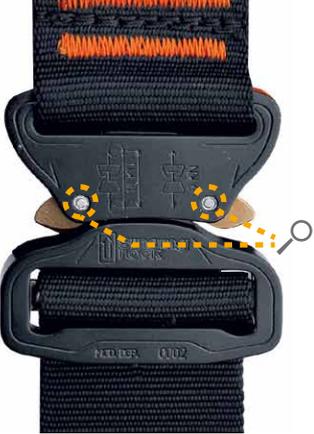
it has come to our attention that in an extremely small quantity (0.00005% = 1 out of 2 million) of COBRA buckles there may exist parts where the rivets have **not** been **press fixed**.

This results in the rivets being loose and the release clips detach. COBRA buckles in all different versions and sizes can be affected. As we are dedicated to the 100% function, performance, quality and safety of our products, we ask all our clients and end users of COBRA buckles to **do a visual check**:

If you notice a buckle that is NOT riveted or you do have any concerns, STOP USING the product immediately and get in contact with us: info@singingrock.com or via phone +420 481 585 007
